**State of Wisconsin \ DEPARTMENT OF NATURAL RESOURCES**

SUBJECT: Estabrook Dam, Field File # 40.08, Dam Safety Inspection Report,  
Milwaukee County.

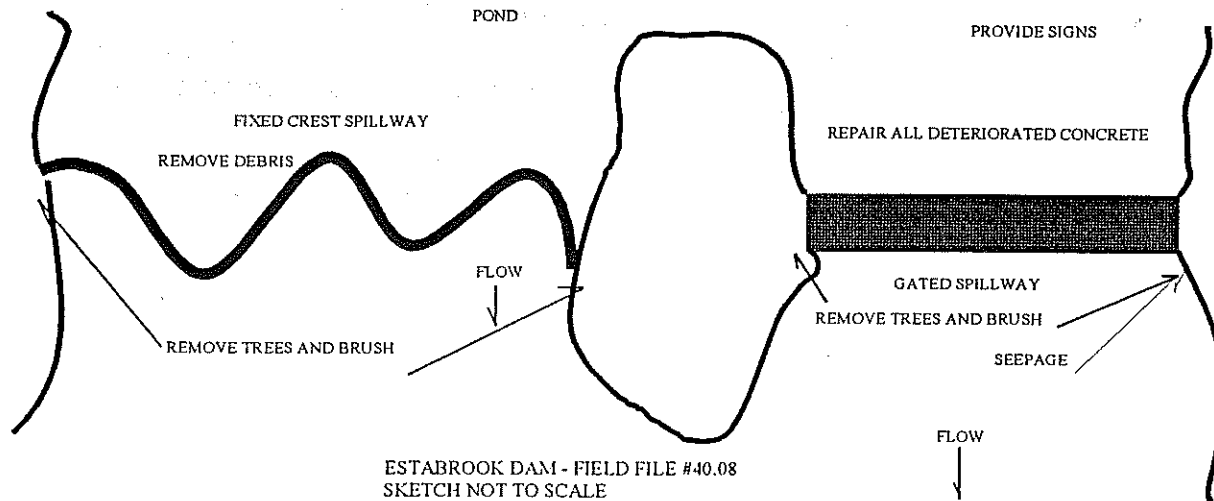
All the piers on the dam are in need of repair. The sprayed on concrete applied in the past has served its purpose and now needs to be removed. New sound concrete must replace the old.

Due to the extent of the needed repairs, Milwaukee County will have to hire an engineer, registered in the State of Wisconsin, to design the repair of the dam. Plans must be submitted to this office prior to their implementation.
