November 22, 2004

Subject: Estabrook Dam, FF#40.08, Inspection Report

ESTABROOK DAM

INSPECTION PHOTO LOG

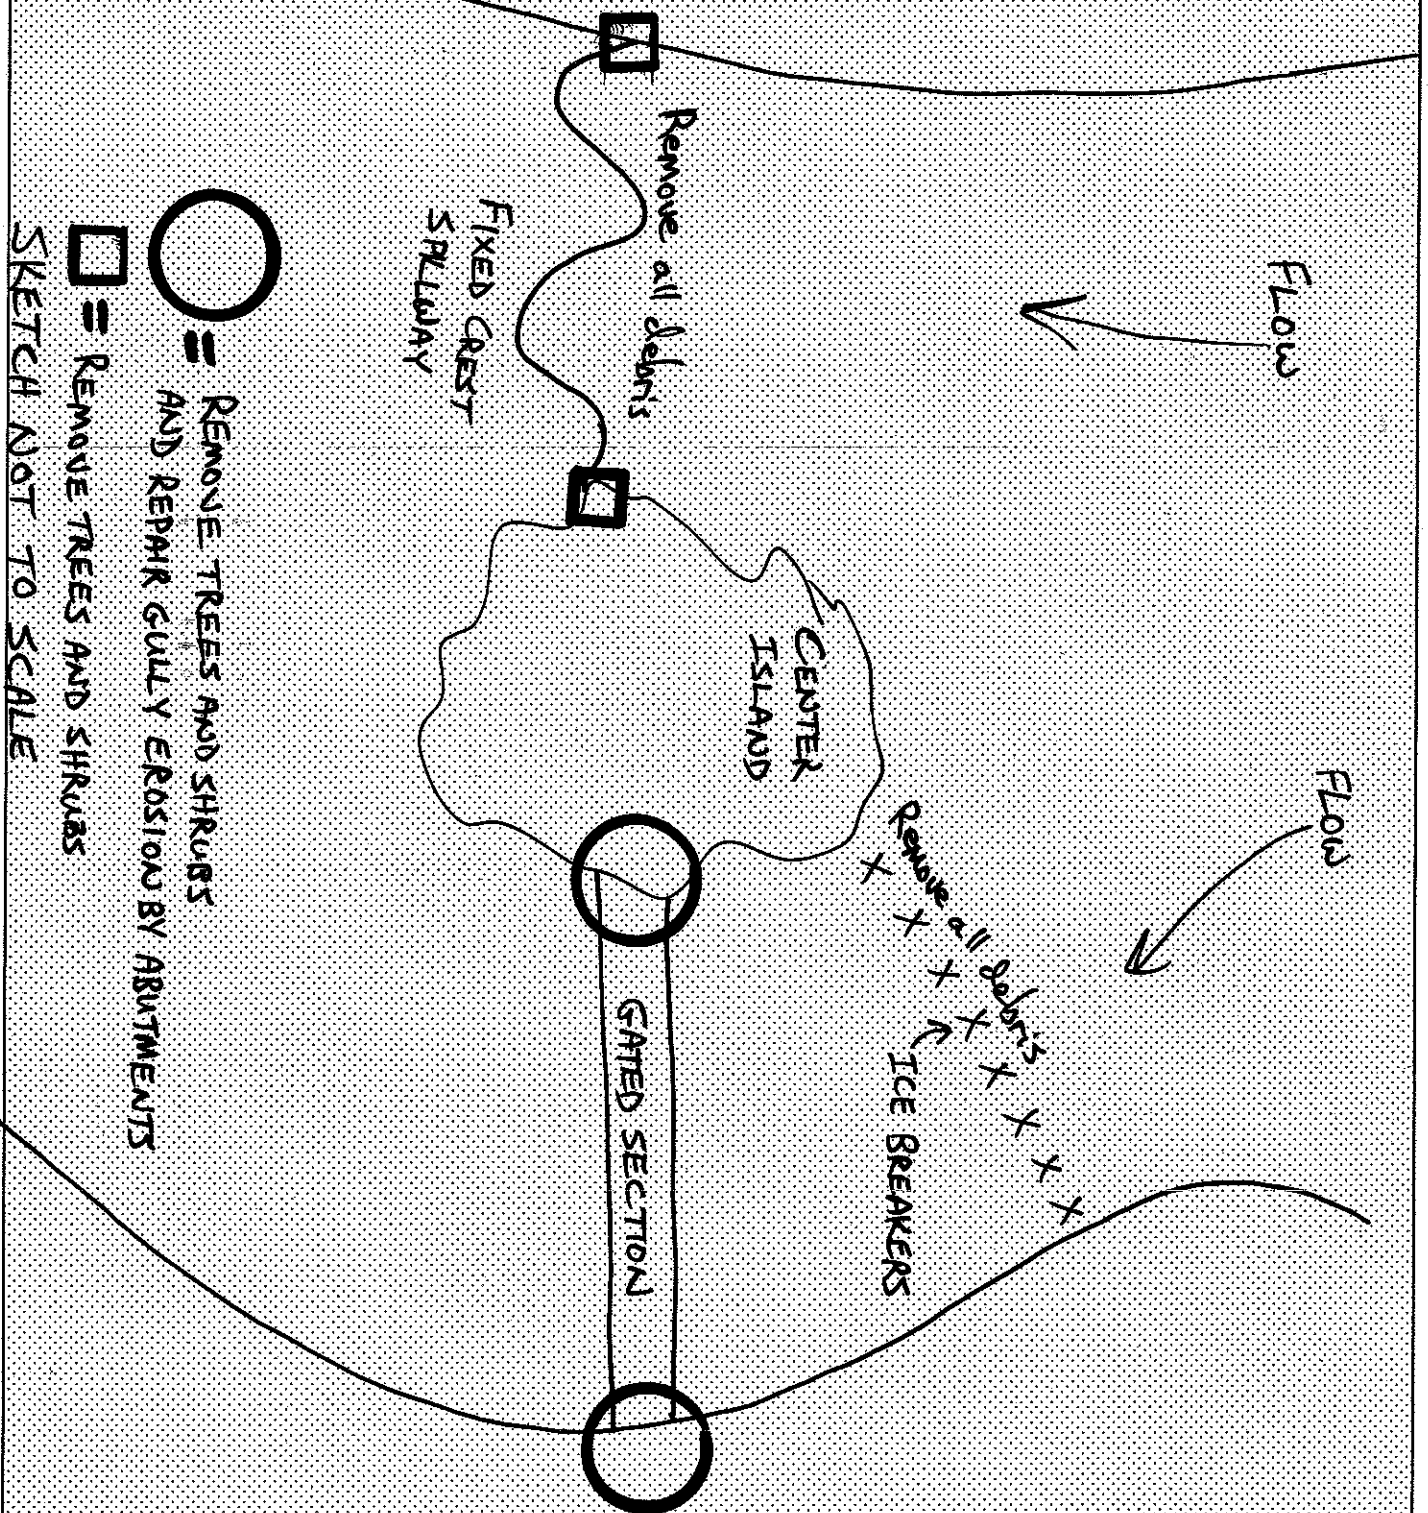
SKETCH

There are cracks in the structure in these locations on multiple supports in the gate section. Need to be evaluated by a structural engineer.

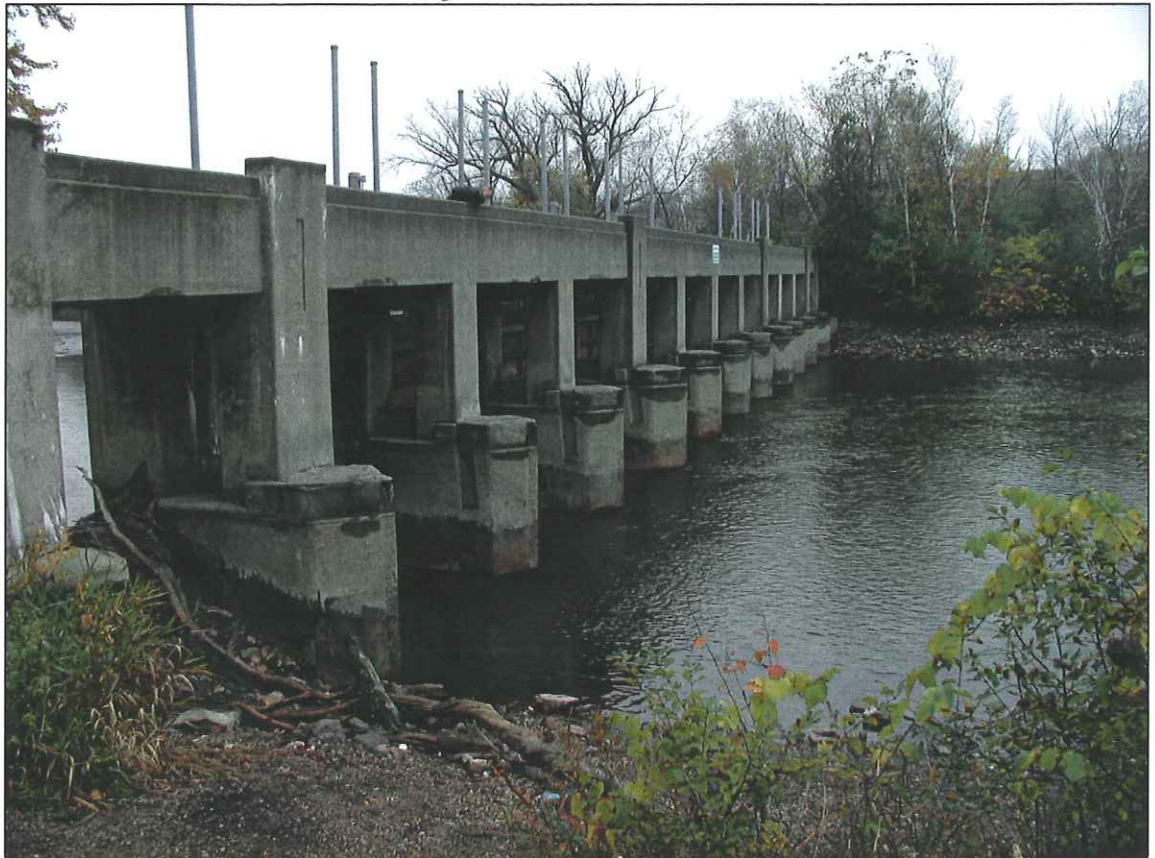
No. 1

D. Piers (number, shape) Condition: *	X	11 piers, gunite spalling off all piers and very damp, gunite will have to be removed and replaced with concrete					X

- 6) Most of the piers on the upstream side of the gate section had gunite applied to them some years ago. This material is now spalling and appears saturated which means it no longer is bonding to the concrete piers (See photos #1 and #2 in the report). All of the piers need to have this material removed and be repaired with concrete. The concrete needs to be at least 6 inches thick and mechanically bonded to the piers. The capacity of the gate section may not be reduced as a result of this repair. This work needs to be completed by December 31, 2006.

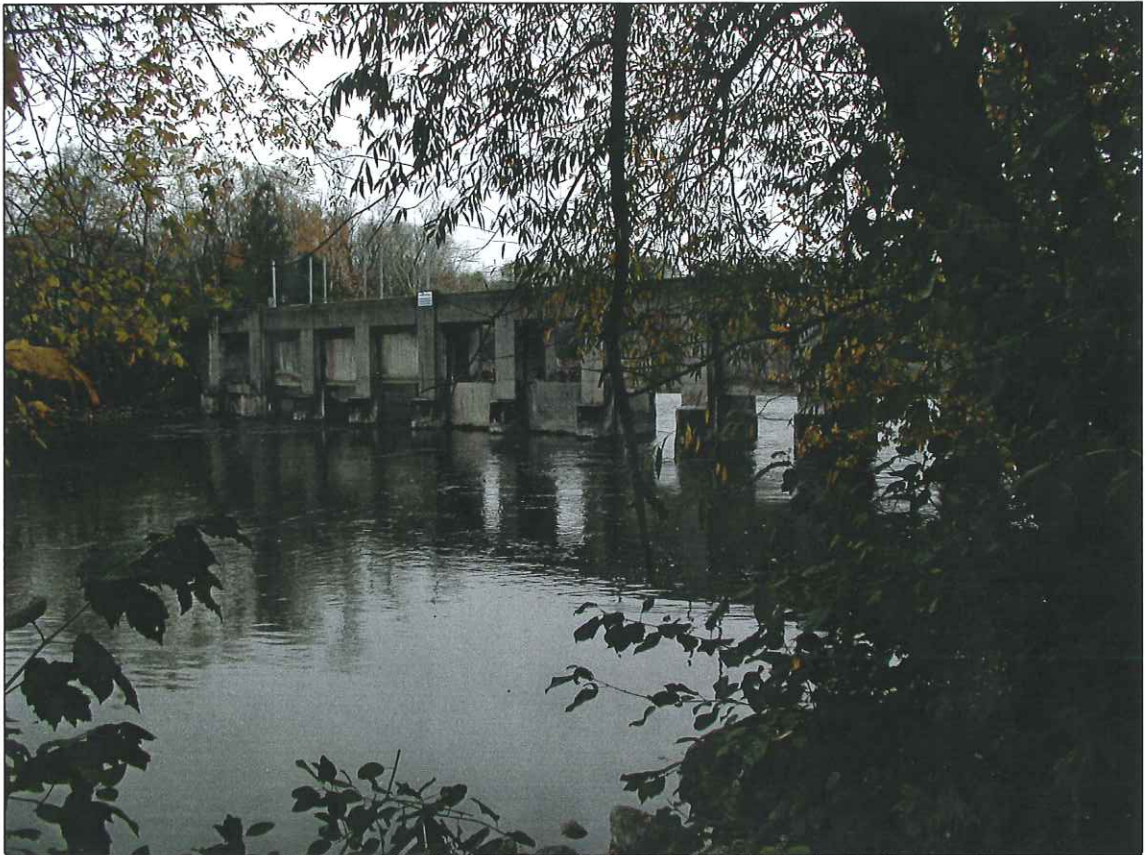
**Photo
No. 3**

E. Operability Type of Operator: Condition(chain, cables,hoists): Security(locked?): Backup Operator:	X	2 of 10 gates not operable (#6 & #7) Gates are power operated from a secure dugout to the left of the dam. No way to manually operate gates					X

- 5) The gates on the dam require a variety of work. All the gates and their tracks are rusty and need to be sandblasted and cleaned. The gate seals should be cleaned or replaced as well. Gates #6 and #7 are currently inoperable and need to be repaired (See photos #3 and #4 in the report). There currently is no way to manually operate the gates. All of the gates must have a manual override. All of this work on the dam's gates must be completed by December 31, 2006.

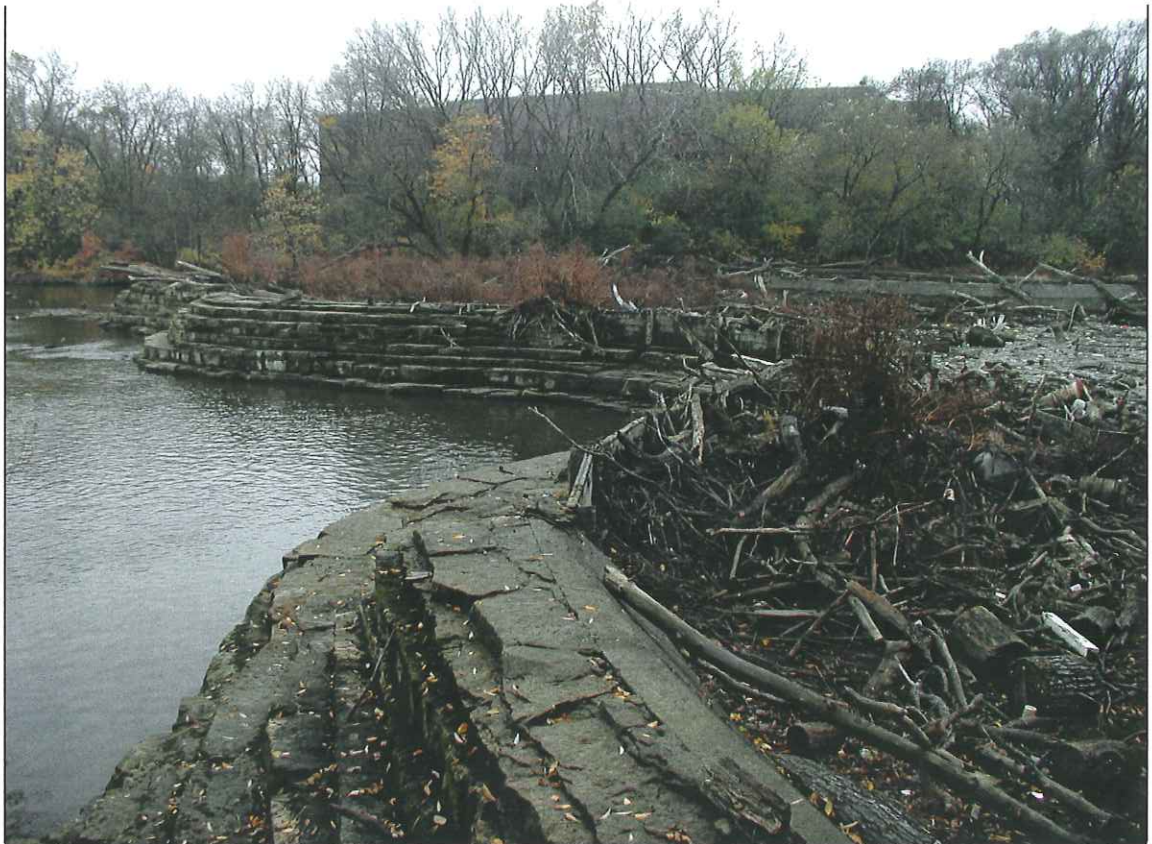
No. 5

D. Debris Prevention (racks, booms, etc.):	X	Massive amount of debris trapped U/S of the spillway. Major clean out needed.					X
E. Concrete Condition *	X	D/S face and crest appear to be in fair condition. U/S face covered by debris so we could not inspect.				X

- 3) There is extensive debris that must be removed from both the fixed crest spillway and the ice breakers upstream of the gated section of the dam (See photos #5, #6, #8 and #12 in the report). The debris appears to consist of large amounts of woody material (logs and large branches) but also a significant amount of man-made material (plastic bottles, tires, park table, etc.). The material will have to be mechanically removed and not burned off as was attempted a few years ago. Mechanical removal will most likely involve some dredging of the accumulated sediment in these areas. Since the Estabrook impoundment is contaminated with PCBs, sediment testing will be required to properly characterize the dredged material for disposal. The debris removal must be completed by December 31, 2005.

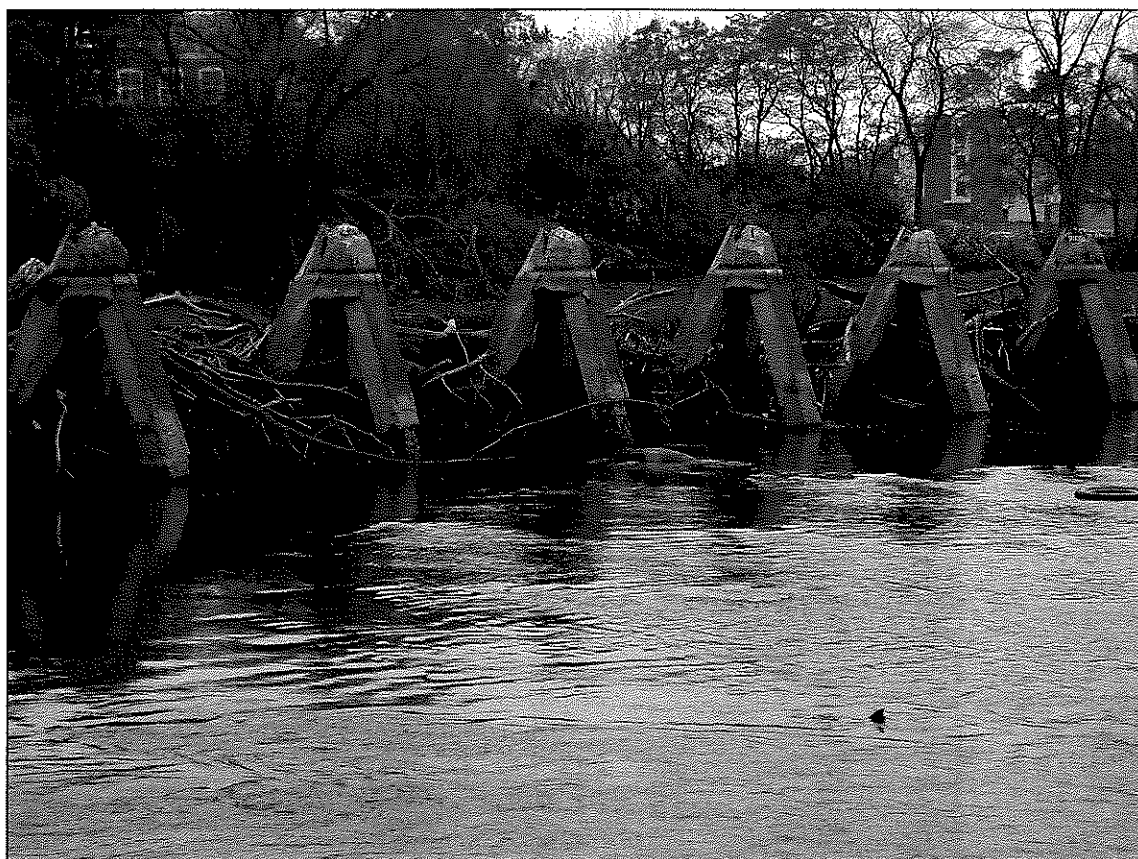
**Photo
No. 8**

H. Ice protection Type (Heaters, Bubblers, Barriers, Other)	X	Ice breakers placed u/s of the dam's gated section. Ice breakers need major work.					X
I. Debris Prevention (Rack, boom, etc.)	X	Ice breakers also catch debris. Major debris removal required					X

- 4) The ice breakers upstream of the gated section of the dam are very deteriorated (See photo #8 in the report). These structures must be removed or reconstructed by December 31, 2006. If removal is proposed, a structural analysis of the dam including ice and debris loading on the gated portion of the structure must be submitted to and approved by the Department prior to removal.

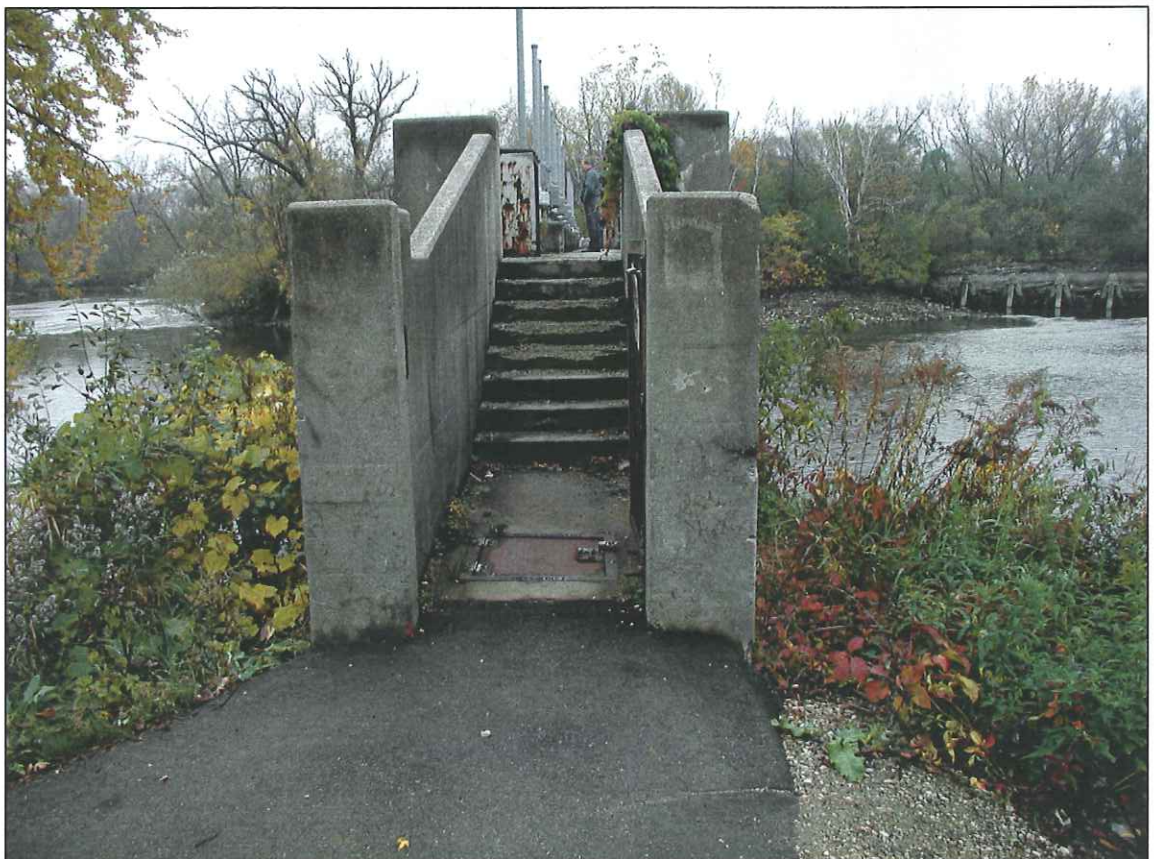
**Photo
No. 10**

Concrete access stairs on the left and right ends of the gate section have deteriorated to the point of being unsafe and need to be rebuilt.

- 10) The concrete access stairs on the left and right ends of the gate section of the dam have deteriorated to the point where they are unsafe (See photo #10). These stairs must be rebuilt by December 31, 2005.
