20
17

MILWAUKEE RIVER BASIN REPORT CARD

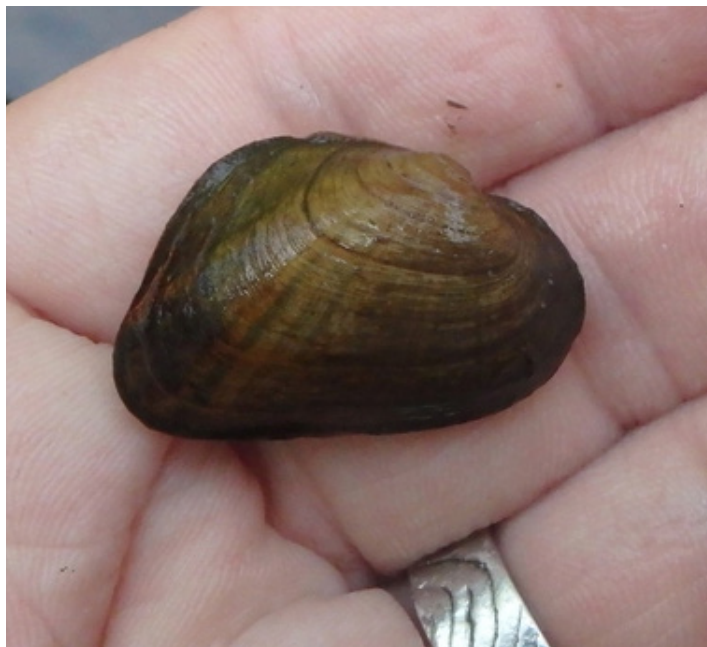
Figure 1. Slippershell mussel (*Alasmidonta viridis*).
Photo Credit: Milwaukee Riverkeeper

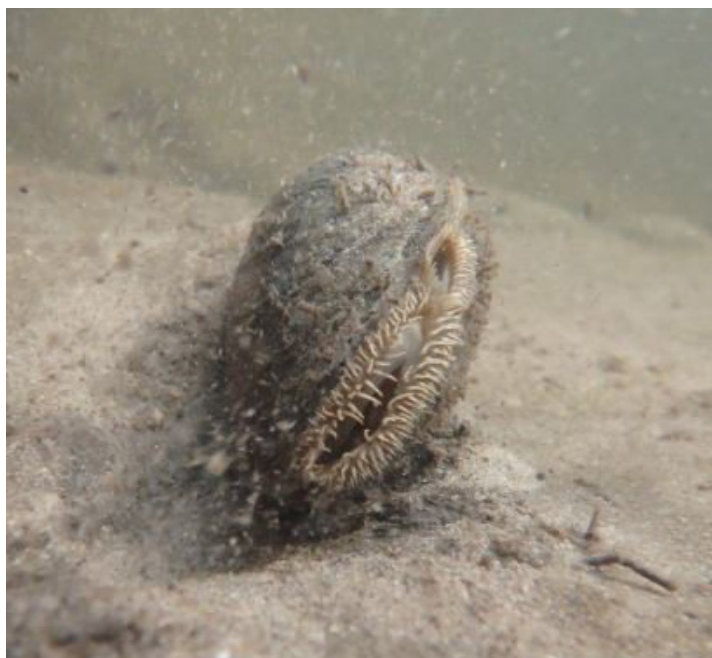
Figure 2. Ellipse mussel (*Venustaconcha ellipsiformis*).
Photo Credit: Milwaukee Riverkeeper
